Manhole Inspection Summary

Manhole # S49E2_003MH

Inspection ☐ Is Incomplete Rating: **1) Excellent**

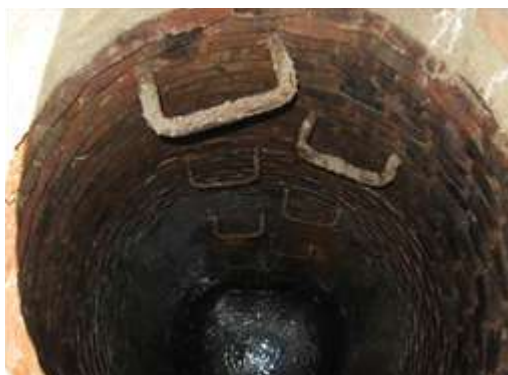
steps

Steps Count: **11** Missing: **0** ☐ Corroded

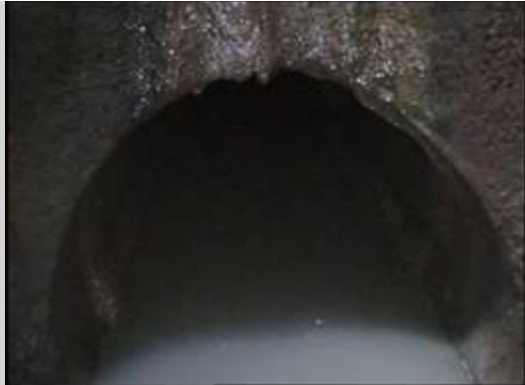
12 O'Clock Outflow

42 in. Circular Gravity Sewer
Pipe Out @ 12 O'Clock

Pipe Height: **34.8** (in.) Rod and Bar (Angled)
Pipe Material: **Unknown** ☐ Pipe Lined
Invert Depth: **17.70** (ft.) Flow Characteristics: **Slow**
Deposits: ☒ None ☐ Mud ☐ Sludge ☐ Debris ☐ Grease
Silt Depth: (in.) Deposits Extent:
Infiltration: **None** Pipe Seal Cond: **Sound**

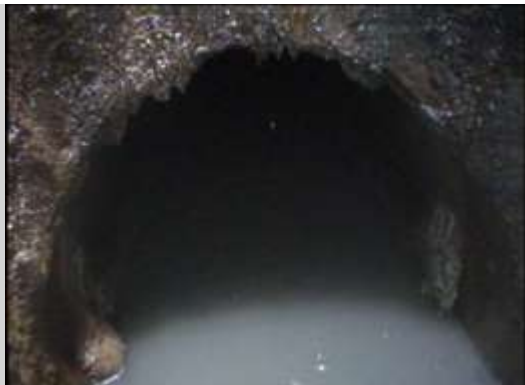
6 O'Clock Inflow

42 in. Circular Gravity Sewer
Pipe In @ 6 O'Clock

Pipe Height: **40.8** (in.) Rod and Bar (Angled)
Pipe Material: **Unknown** ☐ Pipe Lined
Invert Depth: **17.90** (ft.) Flow Characteristics: **Slow**
Deposits: ☒ None ☐ Mud ☐ Sludge ☐ Debris ☐ Grease
Silt Depth: (in.) Deposits Extent:
Infiltration: **None** Pipe Seal Cond: **Sound**
